INSPECTION REPORT

Facility: Coral Shores High School	Date of Inspection: 8/2/2022
Location: 89901 Old Highway Tavernier, FL, 33070	Observer(s): Wood Campbell
Last Inspection Date & by Whom: Unknown	Report Prepared By: Giancarlo Acciardi
Current Use: Internal and rental

Coral Shores High School Theatre Equipment & Rigging

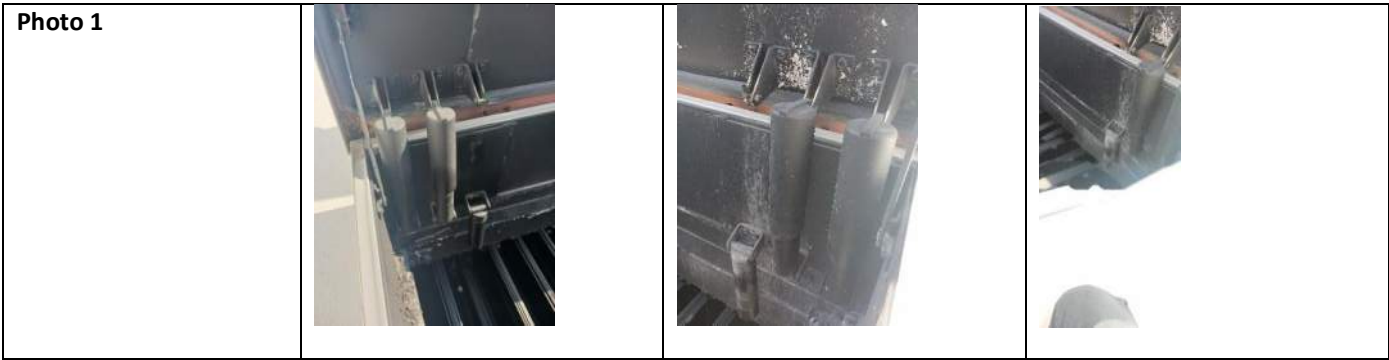
4.	Release Mechanisms	Condition?				Comments	Photo
		NA	Good	Needs Attention	Immediate Attention		
A	Release winch	<input type="checkbox"/>	<input checked="" type="checkbox"/>	<input type="checkbox"/>	<input type="checkbox"/>		
B	Motor / Gearbox	<input checked="" type="checkbox"/>	<input type="checkbox"/>	<input type="checkbox"/>	<input type="checkbox"/>		
C	Fusible Links	<input type="checkbox"/>	<input checked="" type="checkbox"/>	<input type="checkbox"/>	<input type="checkbox"/>		
D	Electro-thermal	<input type="checkbox"/>	<input type="checkbox"/>	<input checked="" type="checkbox"/>	<input type="checkbox"/>	None	
E	Springs	<input type="checkbox"/>	<input type="checkbox"/>	<input checked="" type="checkbox"/>	<input type="checkbox"/>	<p>One door spring has broken off of each of the three sets of smoke hatches. The plastic cap's connection to the door failed and released the spring, which fell.</p> <p>The spring that fell off the Stage Left-most smoke door fouled on the Lift Lines of the #2 electric. This spring was removed this visit.</p> <p>Note: The Stage Left Smoke Hatch blew open during Hurricane Wilma, possibly what caused the spring housing to fail.</p>	<p>1</p> <p>CWT#12</p>

M	15	Add rated cable control hardware or harnesses to protect second S.O. run at strain relief lift point.	Electrical/Rigging Contractor
M	16	Repair/Replace broken springs on Smoke Hatches	Fire Safety Contractor
L	17	Clean corrosion off of affected battens and repaint with rust inhibiting primer to prevent progression.	Staff
L	18	Adjust unlevel battens to even out distributed loads on lift lines.	Staff/Rigging Contractor
L	19	Correct position of #4 loft block on line set 16 to reduce noise and wear to the block.	Rigging Contractor
L	20	Monitor condition of all swaged terminations in system periodically for creep or slippage of the fittings. Especially following heavy loads or shock conditions. Replace immediately if wire rope tails pull into the ferrules or thimbles turn.	Staff/Rigging Contractor

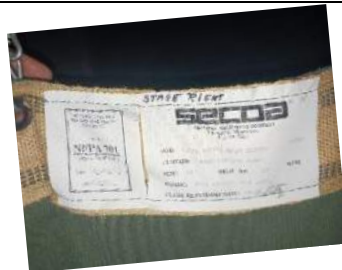
Photo 1

1.	Curtain	Condition?				Comments	Photo	Line Set#
		NA	Good	Needs Attention	Immediate Attention			
A	Condition	<input type="checkbox"/>	<input type="checkbox"/>	<input checked="" type="checkbox"/>	<input type="checkbox"/>	Aging, stained, repaired	1	1
B	Flame Retardants	<input type="checkbox"/>	<input checked="" type="checkbox"/>	<input type="checkbox"/>	<input type="checkbox"/>	IFR Tags dated Nov 2020	2	ALL
C	Traveler	<input type="checkbox"/>	<input type="checkbox"/>	<input checked="" type="checkbox"/>	<input type="checkbox"/>	IFR Tags dated Nov 2020	2	ALL
						Water damage from hatches	3	13
						Sides of the curtain are reversed. Turnbacks are on the offstage side and fire tags are on the onstage sides.	N/A	26
D	Border	<input type="checkbox"/>	<input checked="" type="checkbox"/>	<input type="checkbox"/>	<input type="checkbox"/>	IFR Tags dated Nov 2020	2	ALL
						Water damage from hatches	3	15, 21
