REPORT OF BIENNIAL INSPECTION

TOMMY ROBERTS MEMORIAL STADIUM BLEACHERS KENNEDY DRIVE KEY WEST, FLORIDA

MONROE COUNTY SCHOOL BOARD 1310 UNITED STREET KEY WEST, FLORIDA 33040

**NUTTING ENGINEERS OF FLORIDA, INC. 24478 OVERSEAS HIGHWAY SUMMERLAND KEY, FLORIDA
33042 ORDER NO. 938.4**

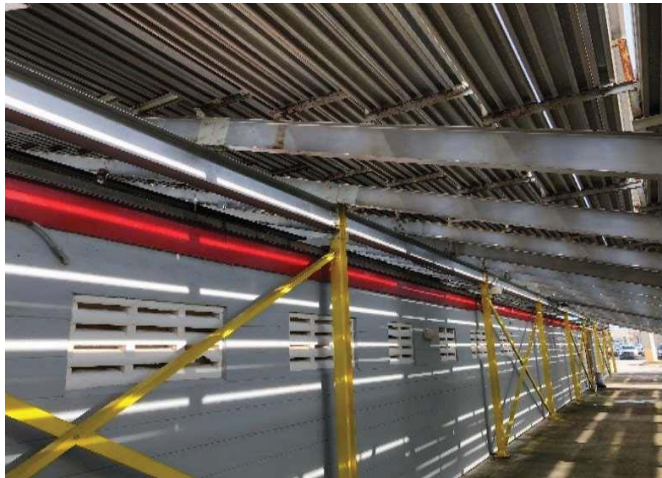
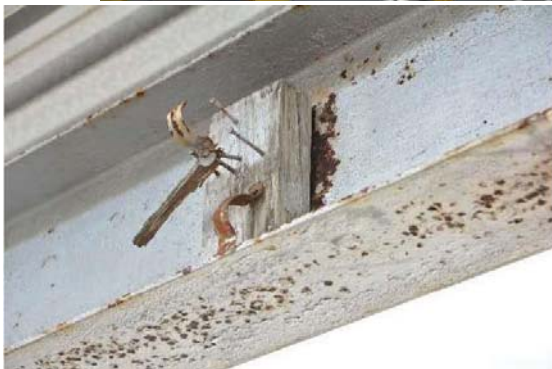
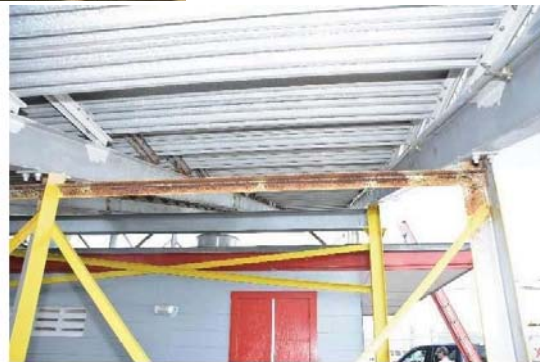
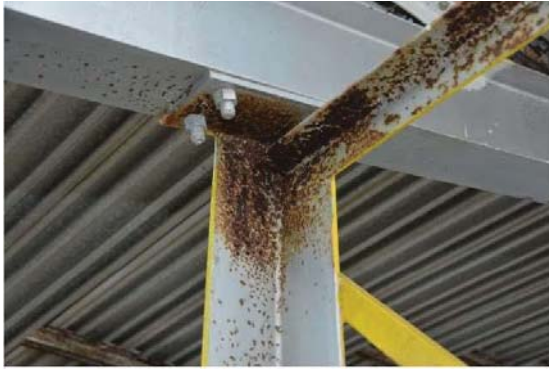
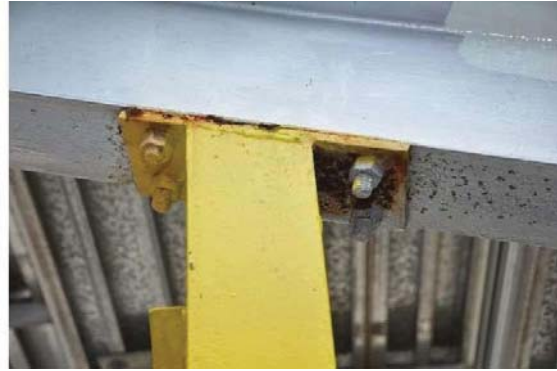
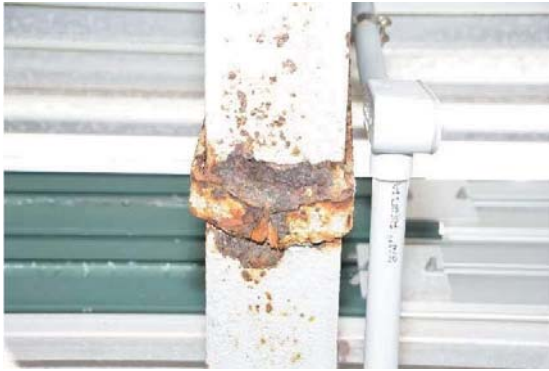
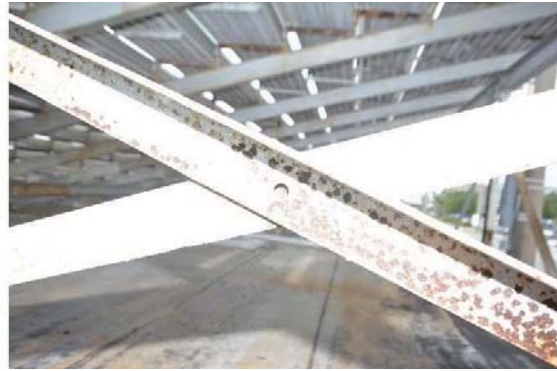
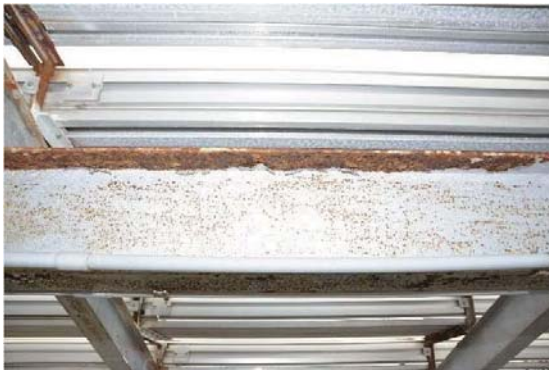
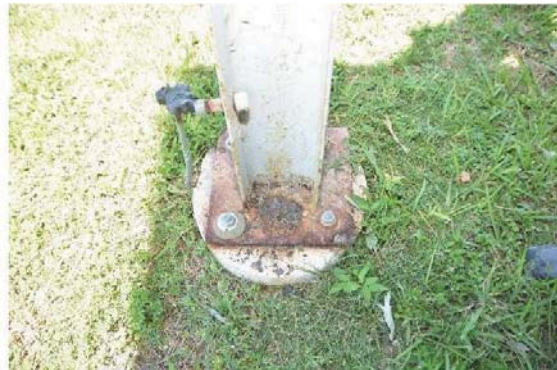
During the inspection, several components of the bleacher system were observed to have various levels of corrosion (rust) with some bolts missing and metal straps that have deteriorated. There are wood blocks attached to steel beams for conduit support, which is causing accelerated corrosion of the steel as the wood allows moisture to be in contact with the steel for relatively long periods of time. It was also noted that supports for the bleacher seats were protected from line 3 to 6 but were not protected from line 1 to 3. The photos below show a general representation of the conditions.

Typical corrosion at connections Corrosion at connections

Corrosion of strap and beam Missing bolt at cross members

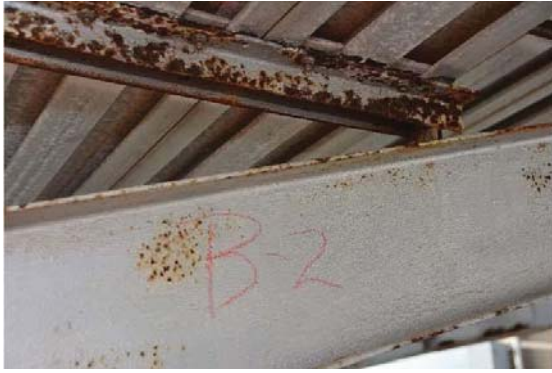
Of particular concern are some main steel support members which are corroding to the point where there is a loss of cross section. These members should be repaired/replaced as soon as possible. Representative photos are shown above:

Corrosion at horizontal seat support Corrosion/Spalling at column base

The bleachers, concession building and press box have been in use for approximately fifty years and various levels of corrosion and deterioration is evident throughout the structures. This report includes general locations of concern as it was not practical to document every location of corrosion/deterioration. All corrosion should be addressed and the structural elements protected from further deterioration. We are available to provide on-site review of the issues documented in this report as needed. The main column supports showing spalled steel should also be repaired/replaced as soon as possible.

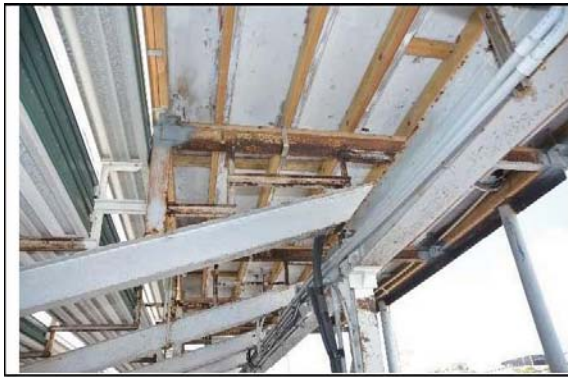
The press box consists of wood framing with hollow shaped steel (HSS) supports welded to the structural I-beams of the bleachers. Three legs consisting of 4½ inch diameter steel columns support the west end of the press box. A variety of welded/bolted steel and nailed hurricane straps were used to connect the press box to the structural supports. Corrosion was noted at the hollow shaped steel and other metal components of the support system. An overview of the press box support system is shown in the photographs below.

Corrosion of HSS at press box

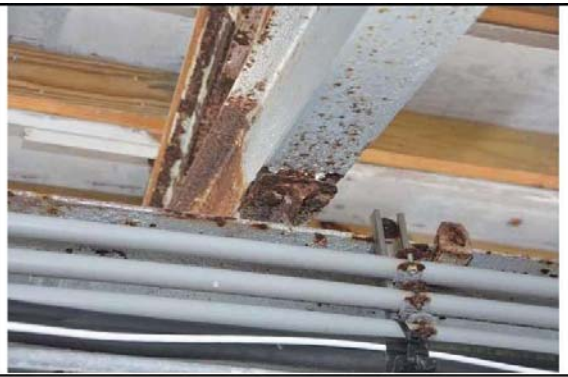
Corrosion of I-beams at press box

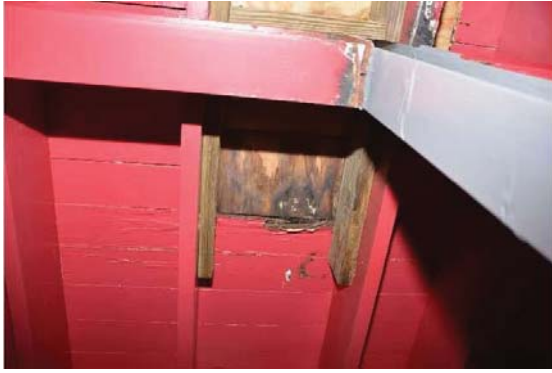
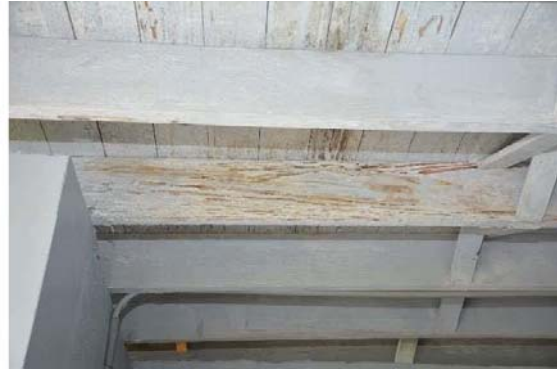
Observations of the concession building indicated water intrusion at the ceiling penetration areas along grid line 2 where the vertical column supports are located. In addition, termite damage to the 2 by 10's and 2 by 8's supporting the roof deck was observed at several locations. The exterior block walls and tie beams appeared to be in good condition. Based on the previous engineering report, it was evident that the spalling identified in that report was repaired. Photographs of the conditions noted are shown below:

Evidence of water intrusion Evidence of termite damage shown above.

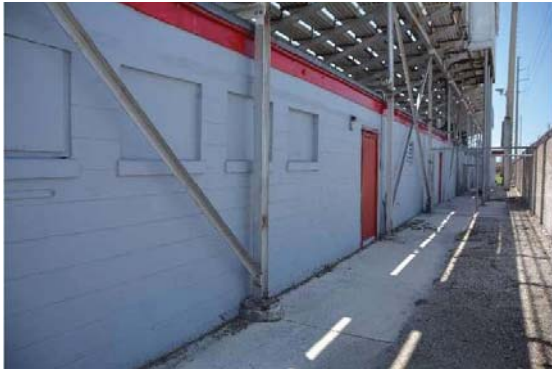
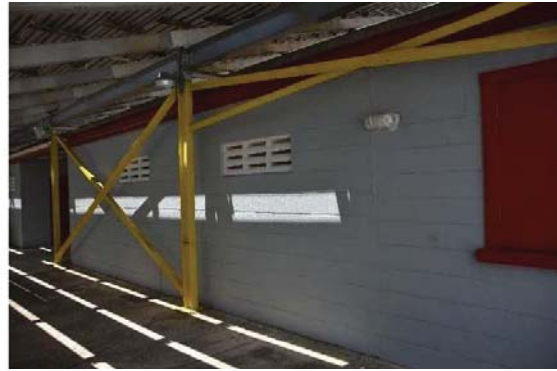
Overview of building west side Overview of building east side
